Science and Education Administration In Cooperation With Food Safety and Quality Service UNITED STATES DEPARTMENT OF AGRICULTURE

METHODS AND FACILITIES FOR GRADING BROILERS AND TURKEYS

By Clarence E. Harris 1/

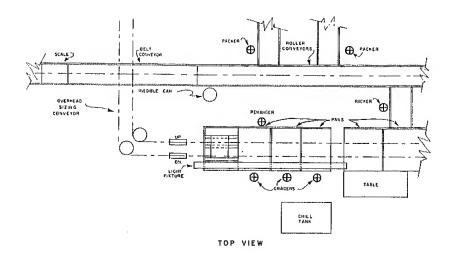
Figure 1.--Layout of broiler grading area in plant A.

- (1) Space is adequate around the graders.
- $\left(2\right)$ Birds are presented at such a height that the graders can easily see the entire carcass,
- (3) The layout necessitates only limited separation of undergrade birds. Once the graders have decided that a bird is an undergrade, they do not have to select from several choices in disposing of it.
- (4) Each grader is required to grade approximately the same number of birds because of the identified shackles and the uniform pacing by the overhead conveyor.
- (5) Adequate adjacent space and facilities are provided for reconditioning birds to meet grading requirements.
 - (6) Lights extend the full length of the grading area.
- (7) The hook of the shackle is turned toward the graders and thus does not obscure their vision of hock bruises and discolorations.
 - (8) The sloped pans keep the undergrade birds away from the graders.

- The top of the pans restricts the graders' accessibility to the birds; they have to reach over the pans to get the birds,
- (2) The light fixture is too far in front of the graders so that the light shines in their eyes.
 - (3) The shorter employees require foot stands.

To alleviate the height problem for the short graders and to make the birds more accessible to others, the overhead conveyor could be raised 6 to 10 inches and a platform with a guardrall around it could be installed in the grading area. This platform should be wide and sturdy to insure safety and it could have adjustable legs so it could be raised or lowered to satisfy the graders' needs. Raising the overhead conveyor by 6 to 10 inches would bring the breast of the birds, suspended from the shackles, to the approximate eye level of graders. For women this is 58 inches from the floor (4).

Since the light fixture is too close horizontally to the overhead conveyor so that it shines into the eyes of the graders, it should be moved away from the overhead conveyor and raised to 6 feet 8 inches above the floor.

Another way to improve the grading operation is to provide more space between graders. In plant A, the pans for undergrade products are 30-1/2 inches apart and tend to limit the workspace for each grader to that width. With the shackles 6 inches on center and the overhead conveyor traveling at 100 shackles per minute past a given point, the grader has only 3 seconds per bird to perform his task when confined to 2-1/2 feet, whereas when the grader has 3 feet of space, he will have 3-3/5 seconds. Therefore, at least 3 feet of space should be provided for each grader. This can be accomplished by moving the table for wing tags and separating the three pans for undergrade birds to 6 inches or more or by using wider pans.

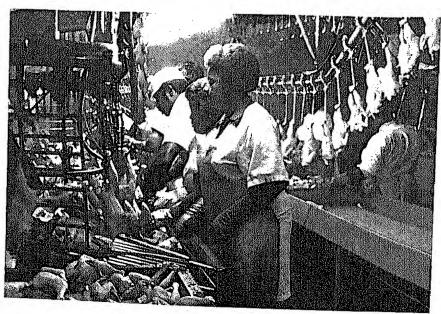
Figure 4.--Hanging birds at the drain rack.

- (8) The drain rack is approximately 17-1/2 feet long, with less than 2 feet of workspace for each of the eight graders and one trimmer.
- (9) The overhead conveyor passes in front of all nine workers at a higher elevation as it goes out and at a lower elevation when it returns, traveling at approximately 250 shackles per minute. Once a grade A bird has been selected, the sorter often has to wait for an empty shackle, especially sorters near the middle of the drain rack. Trying to hang a bird on a fast-moving conveyor line is awkward and inefficient.

The sorting area is too congested. One way to alleviate this problem is to provide more drain rack space or frontage. This could be accomplished by moving the chillers farther apart and adding more rack in that area; however, moving the chillers probably would be costly, both in moving expense and wasted floorspace between the chillers. Another way to get more rack space would be to extend the rack at either end using deflectors or belt conveyors to move the birds out the ends. Complete separation of the two hanging areas, with separate slower moving overhead conveyors, would probably facilitate the highest degree of efficiency; however, this alteration also would be costly. In many other plants the sorting and hanging are performed from a belt conveyor moving in the same direction as the overhead conveyor. Usually the birds slide onto the moving belt conveyor as they come out of the chiller, moving along the conveyor until they are on the overhead conveyor shackles or dropping into a chill tank at the end of the belt. This might be more efficient than the present system.

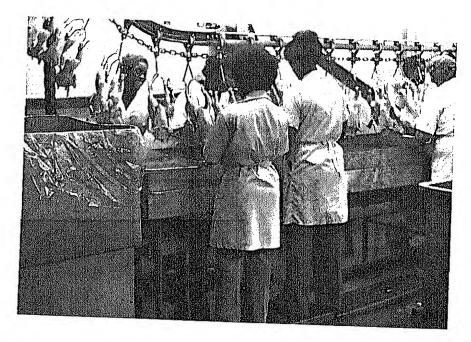
Figure 6.--Grading by authorized graders.

- (1) The grader has difficulty seeing the back of the birds, because they are suspended from the overhead conveyor by nonrotating shackles.
 - (2) Undergrade birds are not easy to remove from the shackles.
- (3) One of the grading positions has inadequate space for grading and not enough room adjacent to it for reconditioning the product.
 - (4) Each grading position is only 24 inches wide.
- (5) Since the floor is not well drained at the grading area, the graders stand on platforms, where their eye level is at about the height of the shackle rather than the bird.
 - (6) The grading area is not well lighted.
- (7) Birds accumulate to an excessive depth in the drain rack at the sorting area and contribute to the inefficiency of sorting and hanging the birds and increasing the probability of some of them being left in the rack for extensive periods.

The grading operation in plant 8 could be improved by increasing the width of the grading stations and improving the floor drainage in the area or raising the height of the shackles at the grading stations. The taller graders have difficulty seeing the lower half of the birds, and if the floor were well drained, these graders could stand on the floor rather than on the platforms. Also, fluorescent or other approved lamps should be installed on each side of the grading line (fig. 3) at a height of 6 feet 8 inches and about 3 feet from the overhead conveyor, and they should provide at least 50 foot-candles of light (3).

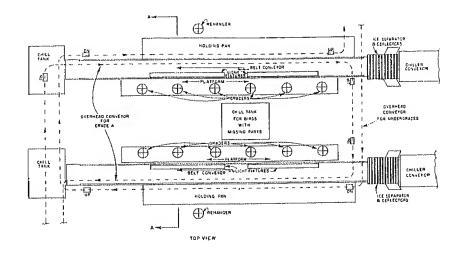
(1) Because the birds are mingled together on the belt conveyors, the production rates of the first two or three graders on the line are restricted since they have to separate the birds before grading them.

Figure 7.--Layout of broiler grading area in plant C.

- (2) Likewise, some of the graders near the end of the belt conveyors have to wait for empty shackles to hang their grade A birds, because many of the shackles have been filled by other graders.
- (3) The grading function is not equally distributed among the graders; the first graders have to grade more birds than those at the opposite end of the grading belts.
- (4) The grading operation occupies an excessive amount of floorspace relative to grading operations in other plants.
- (5) Accuracy and efficiency are less than optimum. Fourteen persons plus support personnel are involved in sorting, grading, and rehanging; some are working close to their maximum capability, whereas others are not.

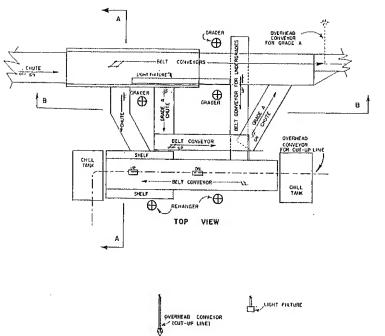
Figure 8.--Layout of turkey grading area in plant D.

- (1) The grading area has inadequate space for maneuvering from front to back of the workplace, and accessibility is restrictive, particularly for two of the grading positions.

- (5) Safety and noise levels at the grading area could be a problem. A belt conveyor operating about 5 to 6 feet above the floor and behind one of the graders could be a safety hazard. The grader has to go under a chute while stepping over another belt conveyor in order to get to and from the grading position. This is inconvenient and unsafe. Noise at the grading area is relatively high because numerous machines are operating close to the graders.

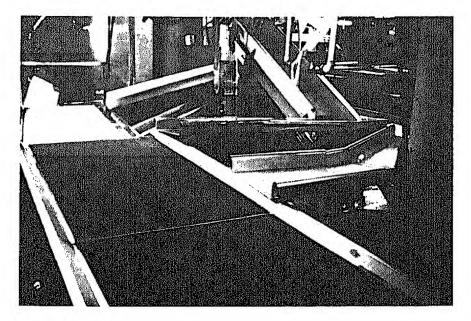
PN-6243
Figure 9.--Belt conveyor for grading birds as they pass from the chiller to
the white belt (background).

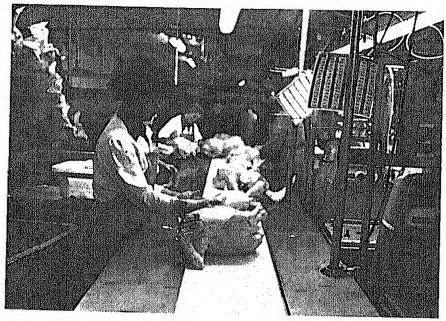
PN-6244 Figure 11.--Turkeys being moved along the belt conveyor to the grading area.

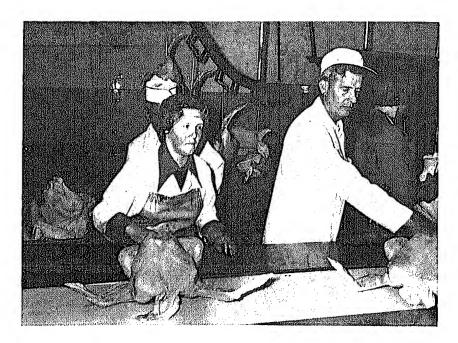
- (1) The belt conveyor and wide shelves on either side provide an excellent working surface at approximately the most desirable height (fig. 12).
- (2) The facilities are easy to clean because all the equipment is movable.
- (3) Lifting of the birds is minimized because the grader is able to see the back without lifting the entire bird. Shackles used in transporting the birds to the packaging area are at a convenient height above the belt conveyor.
- (4) Grading decisions are minimized since all undergrades are deposited in a chill tank.
 - (5) Adequate space is available for another grader when needed.

PN-6245 Figure 12.--Desirable work height of conveyor for short and tall graders.

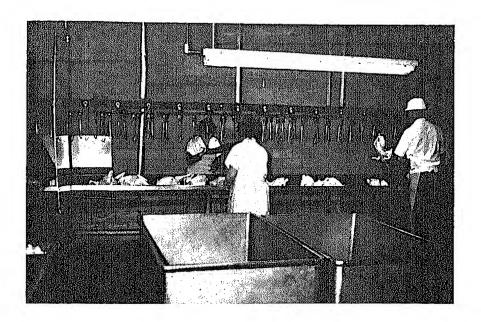
PN-6246 Figure 14.--Grading area with chill tanks for undergrade birds (foreground).

- (1) The grading belt, which is 33 inches above the floor, is too low for most graders, especially with the higher edge of the shelves, which are 37 inches above the floor.
- (2) J hooks moving past the grading area at 4 feet 8 inches above the floor could be hazardous because they are close to eye level.
